Bodie Island Lighthouse Historic Structure Report

BODIE ISLAND
LIGHTHOUSE & OIL HOUSE

HISTORIC STRUCTURE REPORT

**Cultural Resources Division
Southeast Regional Office
National Park Service
December 2004**

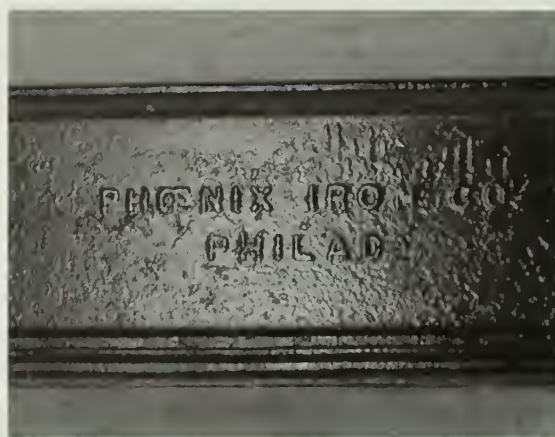
Figure 4 Landing support beams in Tower. Beams were actually installed with manufacturer's stamp upside down. Photo courtesy of Jack McCombs.

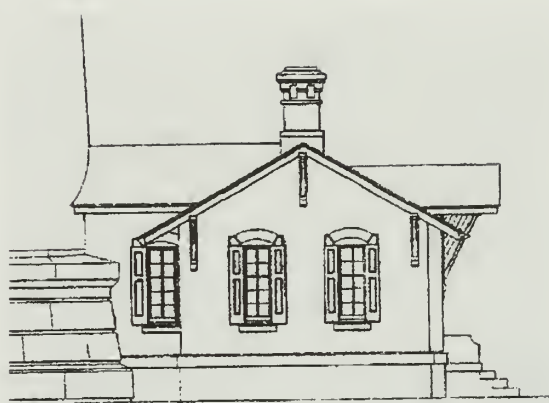
Figure 18 Drawing detail of north elevation.

Overall, the north elevation is in sound condition. However, there are signs of past stress in the cracks over the west window in the elevation. This crack has been patched and painted, is sealed, and appears to be inactive.

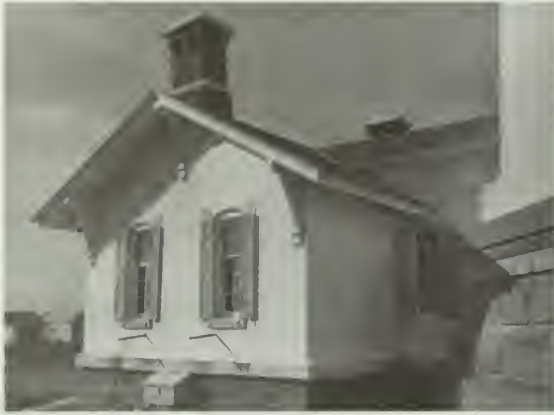
Figure 19 Photo of south elevation by U.S. Coast Guard, 1948.

South Elevation: The south elevation is a mirror of the north elevation in composition. Like the north elevation, the south elevation exhibits a dormant and repaired crack from the west corner of the east window downward and to the east. In addition, there appear to be several patches in the elevation that have repaired brick damage, likely spalling. One patch is over the head of the east window, and one is at the east side and below the sill of the west window. Evidence of spalled brick can be seen on the lower east corner of the elevation below the water table.

There are two patched holes in the center of the elevation below the water table and above the inset in the wall. Earlier photos suggest these patches mark the location of what appear to be drain outfalls from the Oil Room. Mid-20th century photos also indicate the location of a box mounted to the south wall below the water table. The brick shelf defining the inset brick panel below the water table was partly removed to accommodate the box sometime between 1930 and 1948. A portion of a bracket, likely part of the anchorage system for the box, remains attached to the wall. The windows on this elevation are 4/6 like those on the north elevation. However, the east window on the south elevation has a metal screen on a wood frame attached to the window frame. Also present are five brackets for shutters that no longer exist.

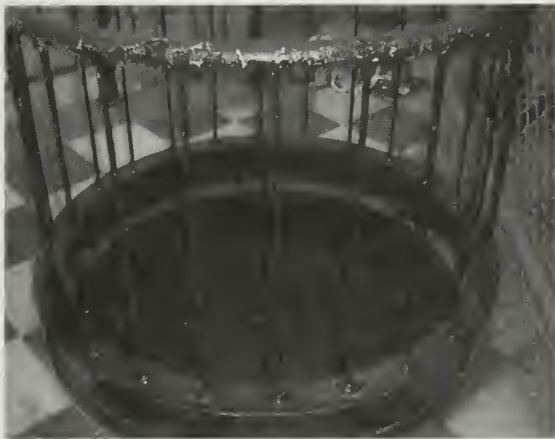
Well: In the center of the ground level is a depressed well approximately 30" deep protected by an original cast iron railing 38" high. The well is constructed of cast iron, with a cast iron wall and cast iron floor, the entire assembly being painted black. The well and railing are in sound condition. The well was reportedly constructed to receive weights used in the operation of a mechanism that would allow the

Figure 23 Well.

light to “flash.” However, the mechanism was never installed, and, thus, the well was never used as intended in the original design.

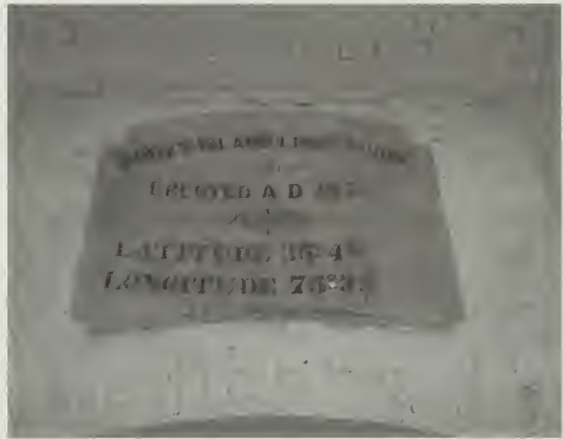
Dedication Plaque: A marble dedication plaque is mounted on the archway facing the center of the Tower (see picture). There are three points of note regarding this plaque. First, the spelling of “Body” is an early spelling of the name, thus suggesting an early fabrication and installation

Figure 24 Dedication Plaque.

of the plaque. The second point of note is that the 1871 construction documents do not show a plaque, suggesting one was designed, fabricated, and installed in an exercise separate from the original construction. Thirdly, this is not the first plaque erected. The original plaque listed the members of the Lighthouse Board and the date at the time the construction of the Bodie Island Lighthouse was begun. An image of the drawing for the original plaque is found in the Chronology of Development and Use portion of this report. The drawing indicates that the location of this plaque is also the location of the installation of the first plaque. The current plaque is in excellent condition, but has some overpainting of white, the result of applications of paint to the wall to which it is affixed, that should be removed.

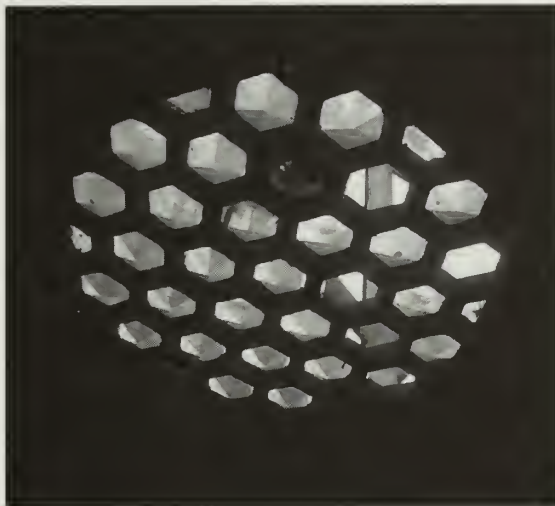
Figure 25 Watch Room ceiling insert made of prismatic glass.

Watch Room level below the lantern, much like the deck prisms of ships. A number of the glass prisms are missing. The cast iron grating and lens pedestal appear in sound condition. On the southwest side of the Watch Room is a penetration in the ceiling for a vent for earlier coal heat at that level. This source of heat has been abandoned.

The grating that serves as both the ceiling of the Watch Room and the floor of the lamp level is missing several of the glass prisms installed in the inserts to provide light to the Watch Room below. This grating and the interior of the muntins in the lamp should be stripped of paint, inspected for defects, and repaired as necessary. Replacement prisms should be fabricated and securely installed in the grating. (It is entirely possible that some of them have been removed in the past as souvenirs.) The grating and the muntins should be repainted as appropriate, consulting the 2002 paint analysis for guidance on paint colors.

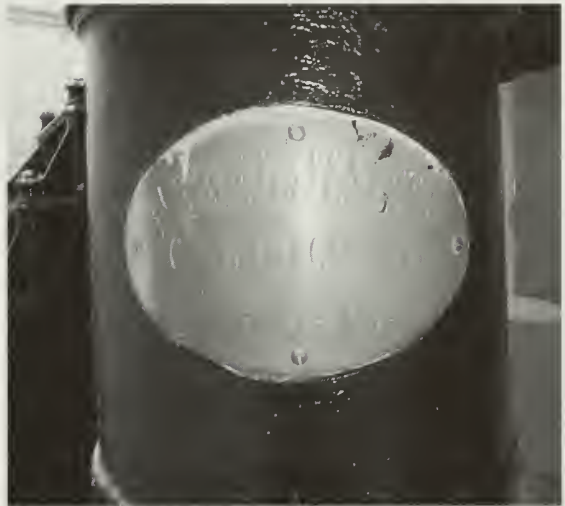
Lens Pedestal: The cast iron pedestal that supports the lens and light positioned in the center of the room is supported by the cast iron floor and framing below. The original manufacturer's brass plaque, in French, is mounted on the post

Figure 26 Lens pedestal, original manufacturer's brass plaque.

of the pedestal. The pedestal is in good condition.

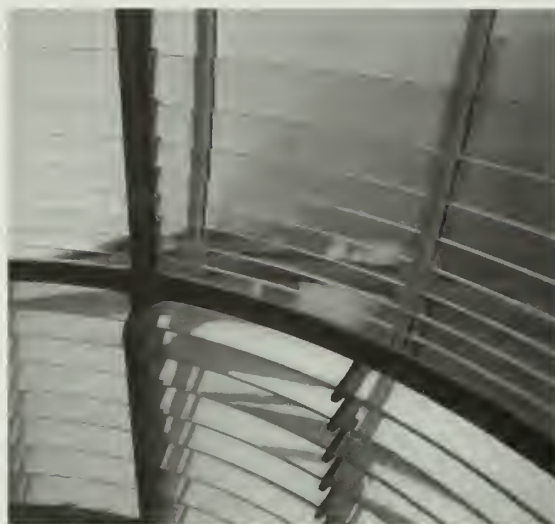
Lens: The lens is a first order Fresnel lens held in position by a brass and iron frame. There are five distinct sections of the lens defined by the position and configuration of the prisms. Except for a few chipped prisms and one missing prism in the second tier from the top of the southeast quadrant of the lens, the lens appears

Figure 27 First order Fresnel lens.

in sound condition. The frame exhibits a limited amount of oxidation in some parts of the cast iron frame. The bronze components of the lens frame appear in good condition.

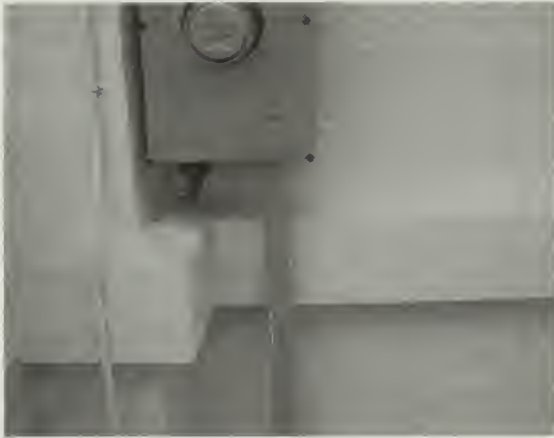
The electrical service entrance for the Bodie Island Lighthouse is provided via underground service. The utility meter is mounted on the west side of the entrance to the Oil House, and the meter indicates 120/240 V service (see Figure 36).

Figure 36 Detail of utility meter.

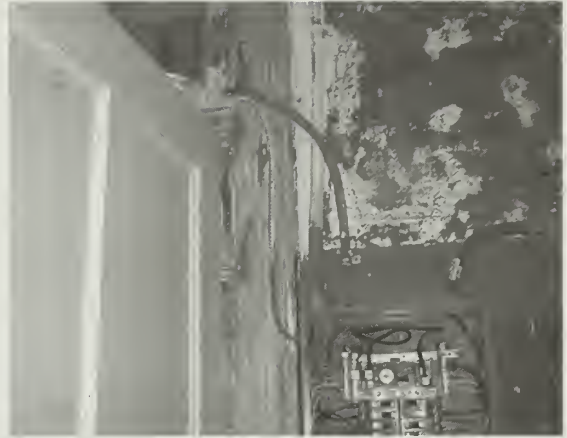
The routing of the service conductors and grounding cable runs from the utility meter to above the door of the Oil House entrance (see Figure 37), penetrates the door (Figure 38), is routed across the south wall of the Hall to above the Oil Room door, and penetrates the door to the distribution panel (see Figure 39).

Figure 39 Detail of electrical wiring access to distribution panel.

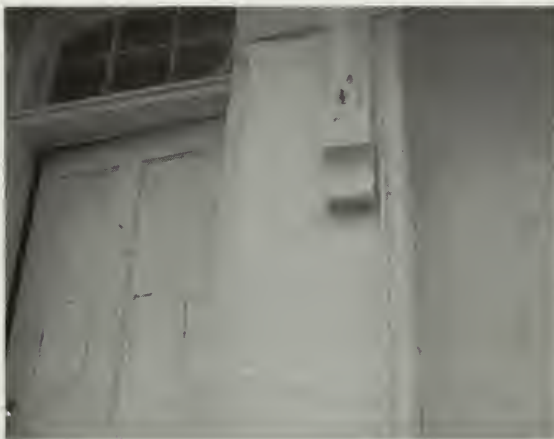
Figure 37 Detail of utility routing through door frame

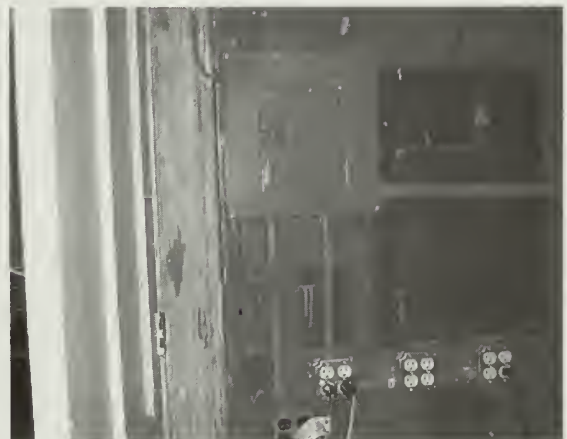
The distribution panel is a 12-circuit panel with a 100A main circuit breaker located in the north wall of the Oil Room (see Figure 40).

Figure 40 Detail of distribution panel.

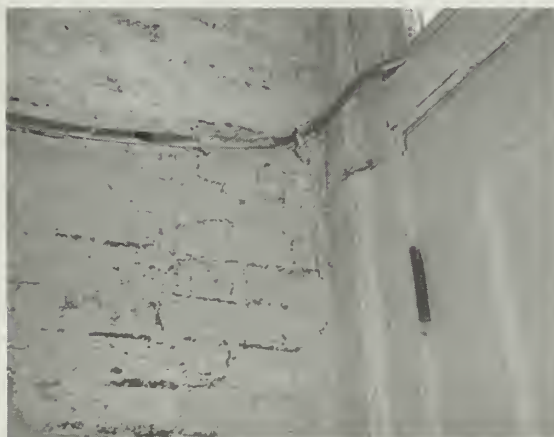
Figure 38 Detail of electrical line.

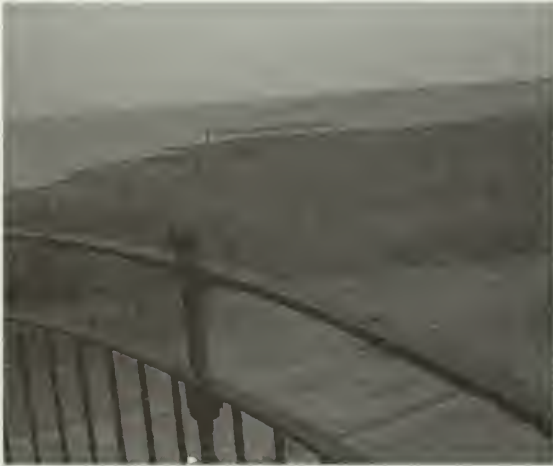
Figure 41 Lightning rod installed on gallery handrail.

There are number of lightning rods installed on the handrail of the gallery and supported by the handrail (see Figure 40) with two opposite down conductors (2/0) on the north and south side of the Lighthouse. The two down conductors are bare copper and are routed exposed to approximately 14' above ground, then routed to a 1/2" schedule 40 PVC conduit to the earth (see Figure 41). There was no indication of what the down conductors were connected to underground (ground rods, ground ring, or both). The original lightning rod at the top of the ventilator ball is no longer connected to any down conductors. However, a bare copper cable runs from a newel post at the base of the Tower stairs, along the perimeter of the ground floor of the Tower, through the window on the north side of the Hall Connection (H/100), and down the wall on the exterior into the ground. This

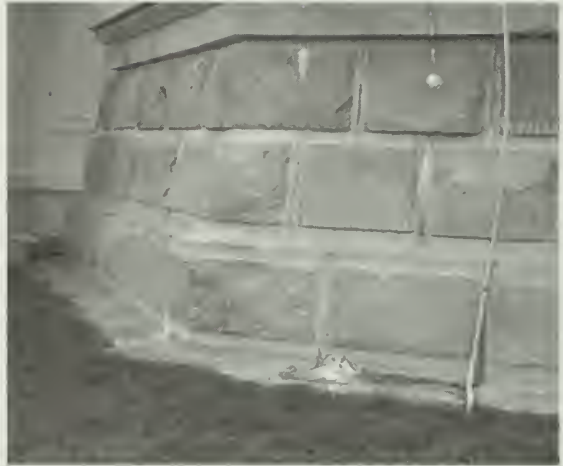
Cables to the main light (circuits number 2 and 4) are in good condition and appear to have been installed recently. The cables are routed through a PVC conduit with fittings from the ground level to the main lights. Conduit and

Figure 42 Conduit for lightning protection, located at tower base.

fittings are in good condition. Conduit continues to the control box in the Watch Room level and then to the main light.

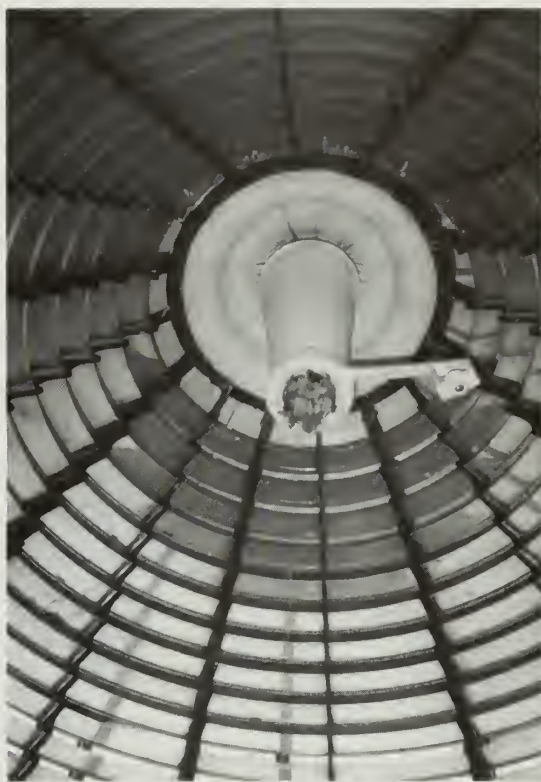
Figure 45 Detail of Fresnel lens.

The Fresnel lens and the light within are the property of the United States Coast Guard. It is not recommended that the Park Service undertake any repair activities on these features. The hood above the lens and the ventilation tube that connects to the ventilator ball are, however, features belonging to the Lighthouse structure. These should be cleaned, repaired if necessary, and painted if required. The ventilation tube is stopped up with some sort of fabric or paper. This should be removed. However, it is desirable to prevent insects, rain, or birds from accessing the interior of the Fresnel lens, so the tube should be stopped with caulk or other waterproof material at a distance inside
